Docket No. 217 – Development and Management Plan Inspection

Northeast Utilities Service Company Certificate of Environmental Compatibility and Public Need for the construction of a 345-kV electric transmission line and reconstruction of an existing 115-kV electric transmission line between Connecticut Light and Power Company's Plumtree Substation in Bethel, through the towns of Redding, Weston, and Wilton, and to the Norwalk Substation in Norwalk, Connecticut.

Date: November 11, 2004

Location: Norwalk Substation Expansion

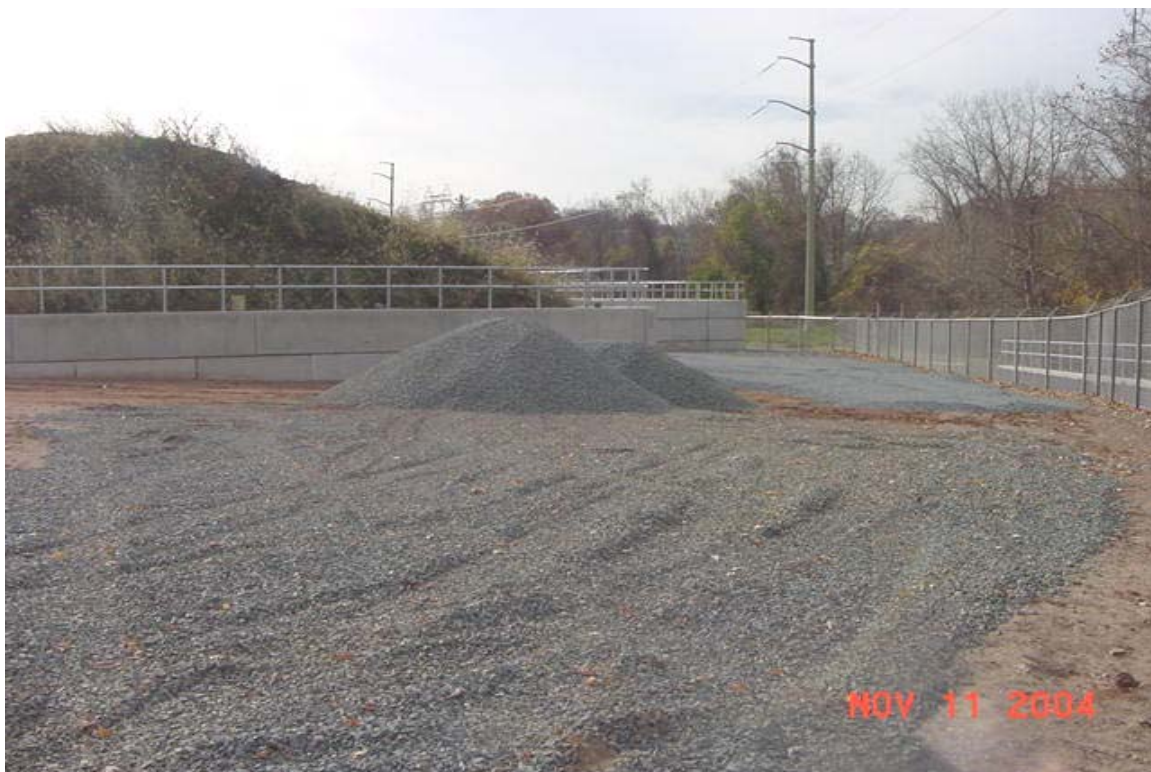
Crushed stone is being spread throughout the yard including behind wall #2 (shown here) between the control building and wall #3, and the perimeter fence and wall #3. 11/11/04

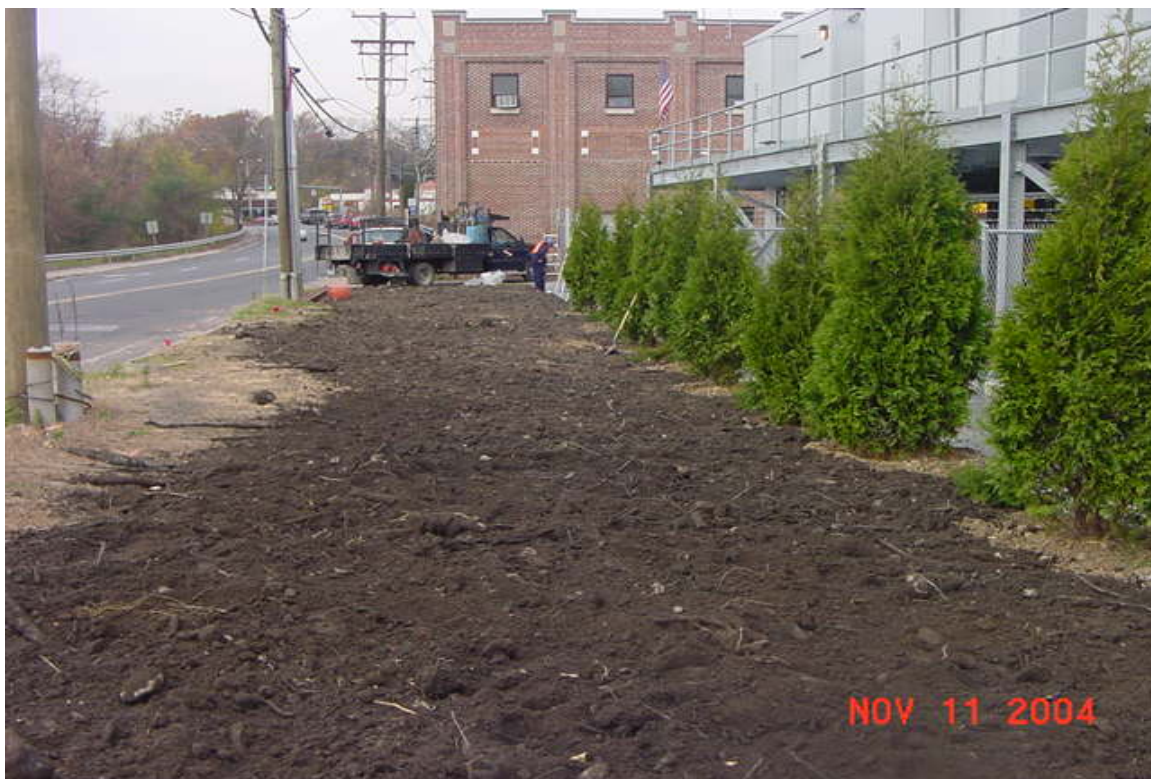
View of topsoil being placed at the perimeter fence at New Canaan Avenue. Plantings were also recently placed here. No sediment has been tracked onto the roadway at this time. 11/11/04

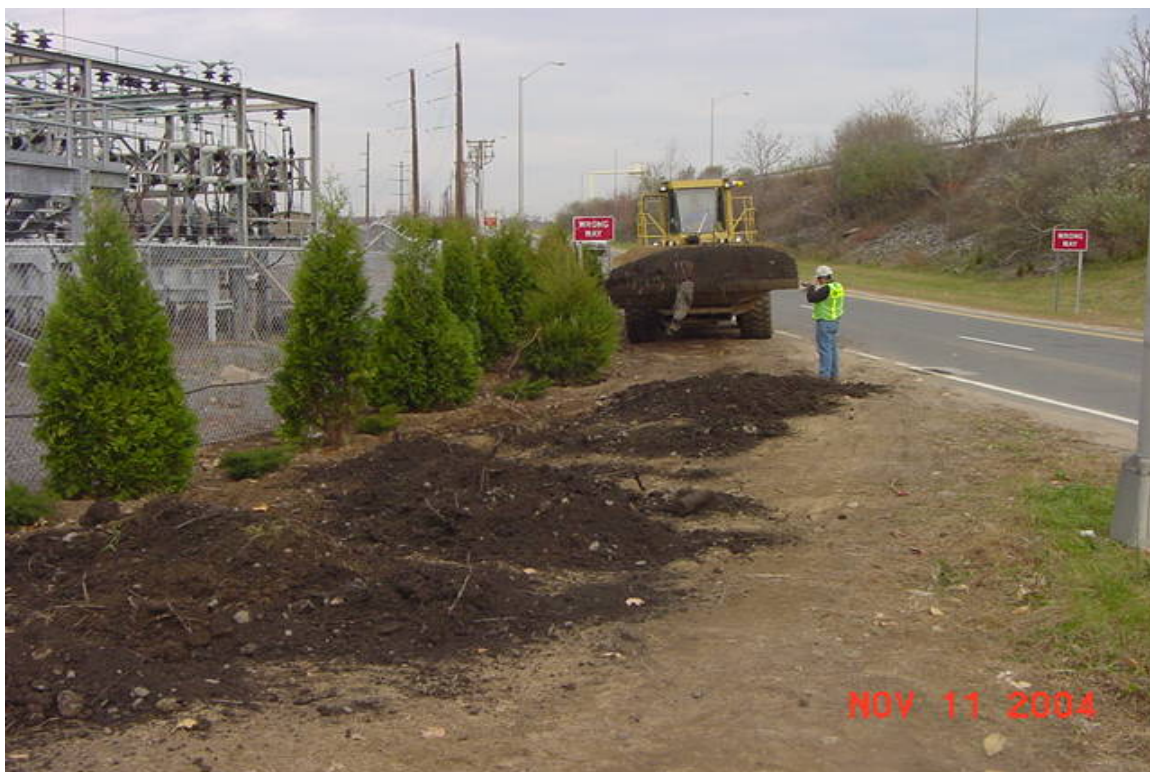
Plantings, topsoil and crushed stone are also being placed along the perimeter fence and the Route 7 ramp. No sediment has been tracked onto the roadway at this time. 11/11/04

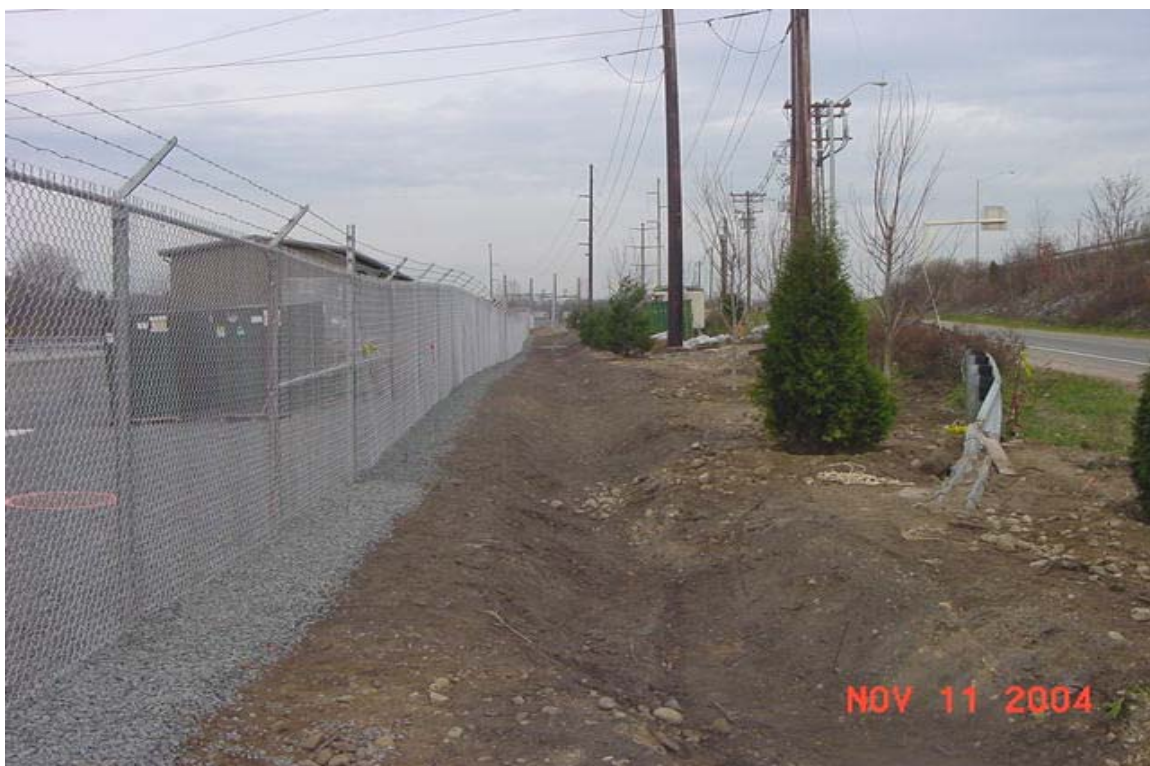
Another view of the perimeter fence near the Route 7 ramp. The ditch has recently been seeded and the landscaping is ongoing. 11/11/04

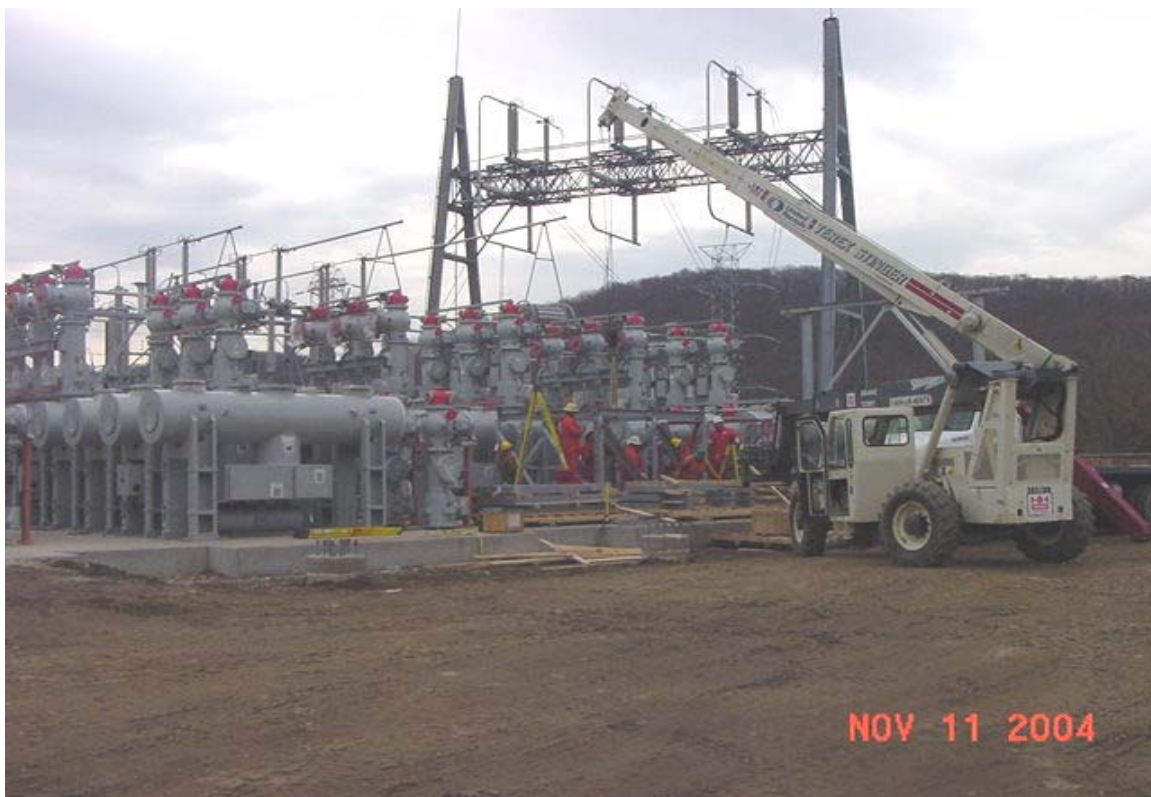
Plumtree Substation: View of the continuing placement of equipment on the concrete slab. 11/11/04

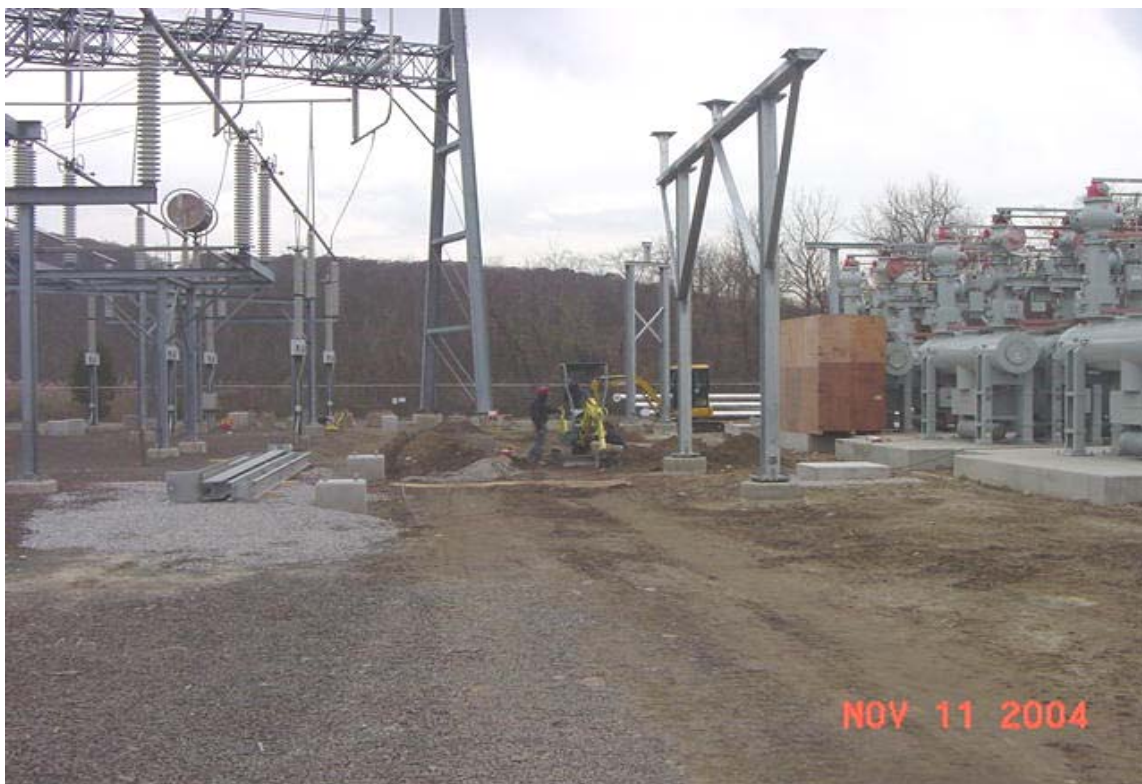
Minor excavations are ongoing for installing cable connections to the equipment on the concrete slab. 11/11/04
